# Thorndon Connections cycleway audit – safety and accessibility

30% design audit

November 2022

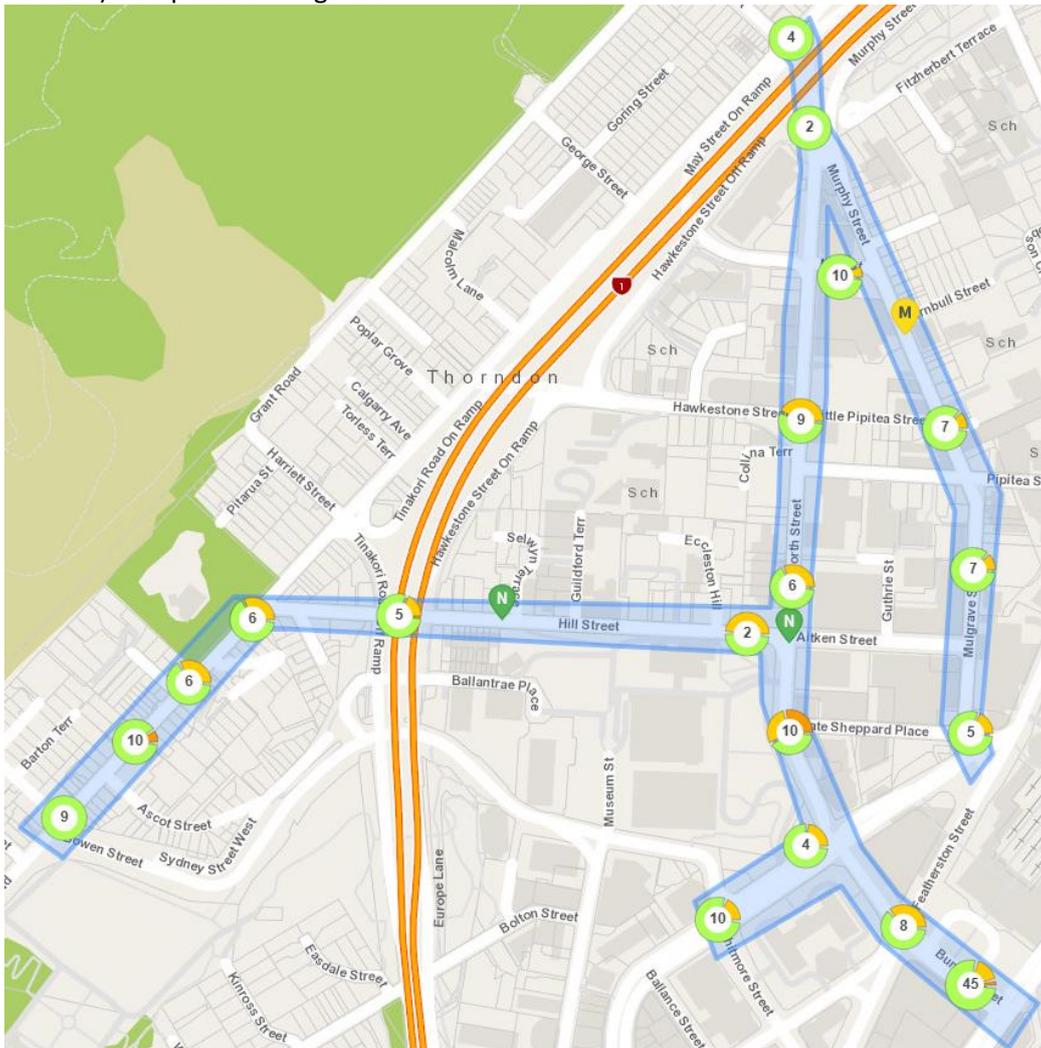
**Figure 3-1: all crashes reported in the proposed Thorndon connections corridor**

A total of 168 crashes were reported along the proposed Thorndon connections project corridor over the five-year period; the user groups and severities involved are detailed in

The largest crash clusters involving motor vehicles are on Bunny Street near the railway station. Other notable crash clusters are present at intersections between Molesworth Street and Kate Sheppard Place, Bowen Street and Tinakori Road, Bowen and Whitmore Street (more information on these clusters are included in Appendix A). These should be considered during the design process.

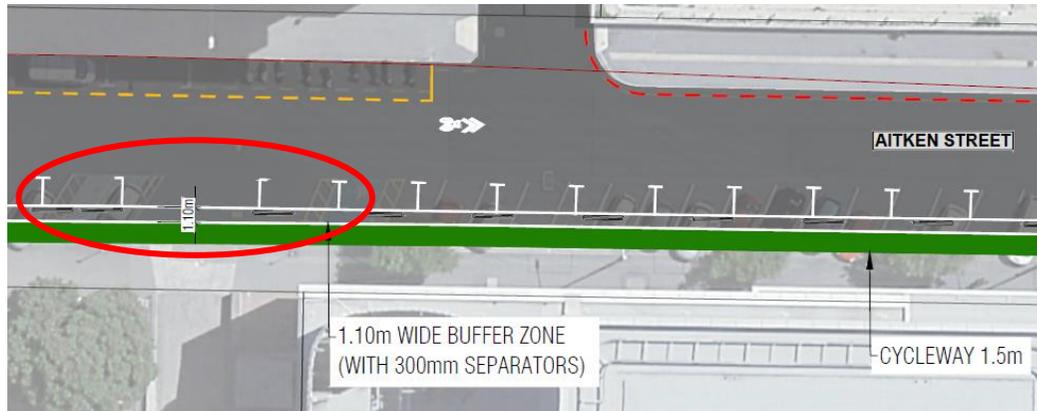
Figure 4-1: Aitken St driveway

The crash type expected is conflict between a motor vehicle entering the driveway and a cyclist on the cycleway, due to the driver’s view of the cyclist being blocked by parked cars. The risk factors are the high parking occupancy along Aitken St and the assumedly high turning volumes into the driveways.

The relevant guideline is Waka Kotahi’s cycling network guidance (CNG) [Technical Note on separated cycleways at side roads and driveways](#), which states that when there are more than four parking spaces on the approach to the driveway, the closest parking space should be set back 8 m from the driveway. On the downstream side a minimum setback of 3 m is recommended. The CNG [High-use Driveway Treatment for Cycle Paths and Shared Paths Design Guidance note](#) gives extra information for treatments at high-use driveways.

Probability of crash occurring	Likely
Expected crash severity	Minor injury
<b>Primary treatment recommendations:</b>	
4.3.1	Increase parking setbacks to driveway to comply with CNG <a href="#">Technical Note on separated cycleways at side roads and driveways</a>
<b>Supporting treatment recommendations:</b>

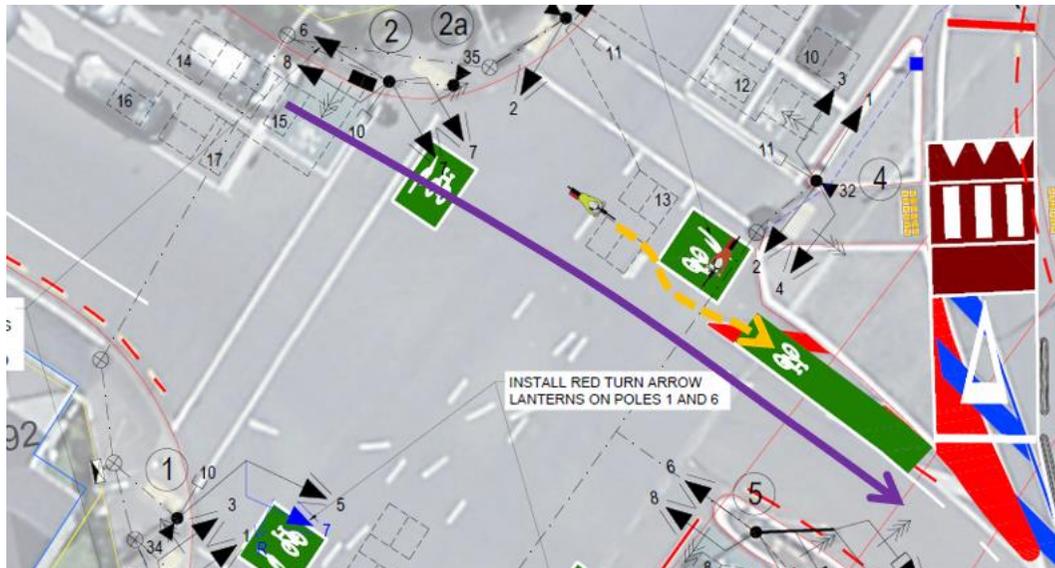
The safety issue is the hook turn box in the north-east quadrant of the intersection sits partially in front of the departure cycle lane on Molesworth St. Therefore, cyclists waiting in the hook turn box could block the path of travel of cyclists heading through from Park St or the hook turn box in the north-west quadrant, forcing them to cut into the general traffic lane (see Figure 4-2).

**Figure 4-2: Through-cyclist deviating to avoid cyclist waiting in hook turn box**

The crash type expected is motor vehicle vs cyclist.

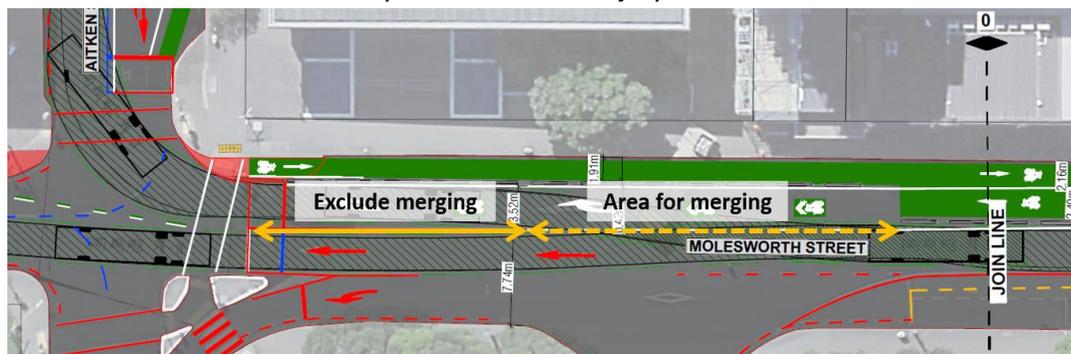
There is currently little available NZ guidance on the design of mixing lanes, however ViaStrada are currently working on a technical note for Waka Kotahi on the subject. It is expected that cyclist volumes will be high in these locations, as are traffic volumes; given also that mixing lanes are not common in Wellington, the probability of a crash occurring is likely. Given that motor vehicles are expected to be travelling around 30 km/h, crashes that do occur would likely result in serious injury.

Figure 4-3: Areas of mixing lane where merging is allowed vs excluded, based on vehicle tracking

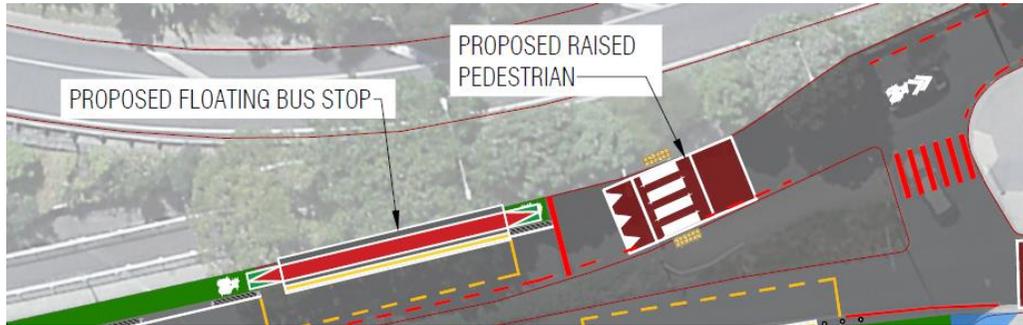
The safety issue is southbound cyclists on Murphy St transitioning from the cycleway to mixed traffic immediately after the floating bus stop (see issue 4.7) and immediately before the new raised pedestrian crossing.

**Figure 4-4: cycleway transition to mixed traffic between bus stop and pedestrian crossing**

The crash type expected is conflict between a cyclist and a motor vehicle.

Probability of crash occurring	Unlikely
Expected crash severity	Minor injury
<b>Primary treatment recommendations:</b>	
4.8.1	Shift the bus stop northwards, so a merge can be established prior to the pedestrian crossing (this may also help addressing issue 4.7).
4.8.2	OR continue the cycleway past the pedestrian crossing and merge downstream.
<b>Supporting treatment recommendations:</b>	
4.8.3	As well as providing sharrows at the merge location, provide sharrows just prior to the merge, to alert drivers.
4.8.4	Put sharrows in green boxes, to emphasise the merge to mixed traffic.

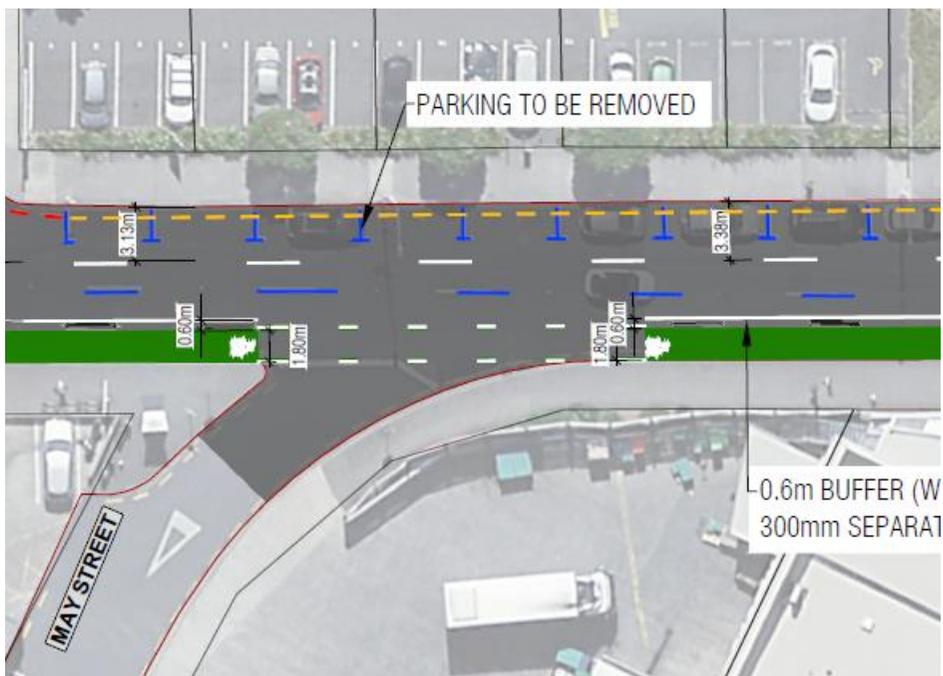
The safety issue is the low angle between the direction May St drivers are heading, and the direction they must look back over their shoulder to see cyclists approaching on the cycleway. Figure 4-5 shows the site location.

The crash type expected is motor vehicle vs. cyclist.

**Figure 4-5: May St low angle slip lane across Murphy St cycleway**

Probability of crash occurring	Unlikely
Expected crash severity	Serious injury
<b>Primary treatment recommendations:</b>	
4.9.1	Cycleway (and pedestrian) raised platform across May St.
4.9.2	Painted island or mountable kerb extension to square up May St approach and reduce vehicle speeds, while still accommodating tracking of heavy vehicles
<b>Supporting treatment recommendations:</b>	
4.9.3	A more conspicuous marking treatment of the cycleway across the side road.
4.9.4	Note the existing limit line needs to be relocated.

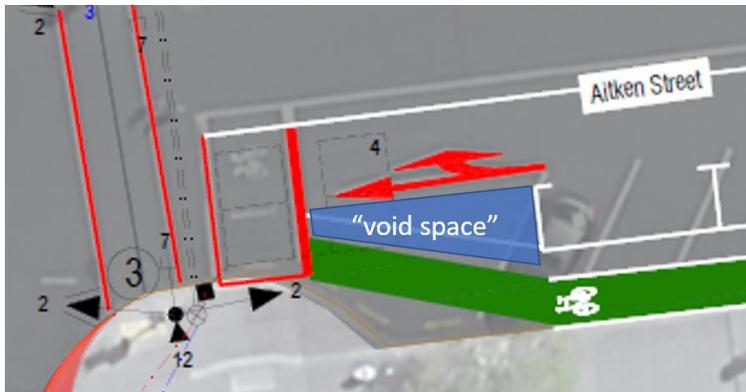
The risk factors for the Aitken St approach include right-turning cyclists having to get past the parallel through-traffic, as they are originating from a kerbside cycle lane. This is complicated by the taper on the cycle lane after the termination of the parking – drivers may use the “void space” (see Figure 4-6) to form two queues. Also, right-turning cyclists will want to wait a shorter distance into the intersection than right-turning drivers, because the cycle lane on Molesworth St is on the right-hand side.

Figure 4-6: void space on Aitken St approach

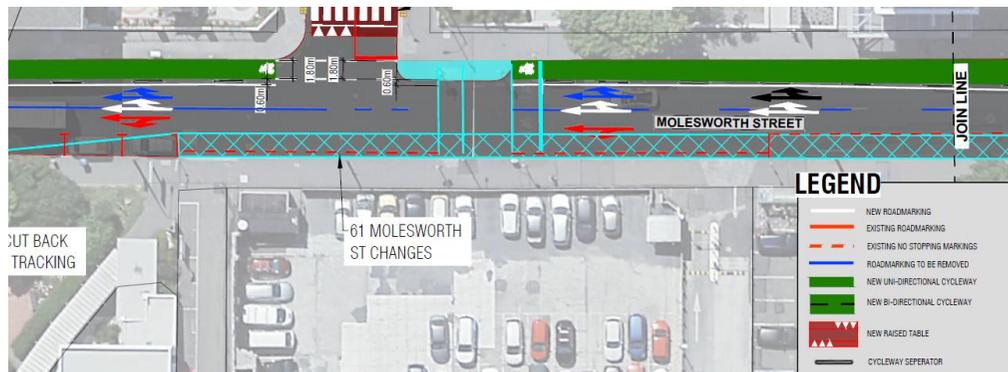
The design colour coding suggests existing shared through / left-turn lane to be retained, and through / right-turn lane to be shifted over, however this does not properly reflect the intention of there being one lane only in this section.

**Figure 5-1: Lane markings at 61 Molesworth area**

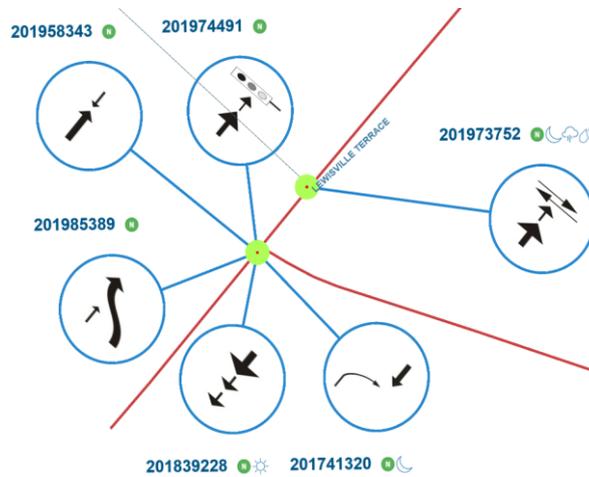
**Figure 6-1: Bowen Street and Tinakori Road intersection crash diagrams**

- crashes were most often to do with manoeuvring
- none involved pedestrians or cyclists
- one occurred in wet conditions
- two occurred at night
- crashes occurred the most on Wednesday or Friday
- four of the six crashes occurred in 2019

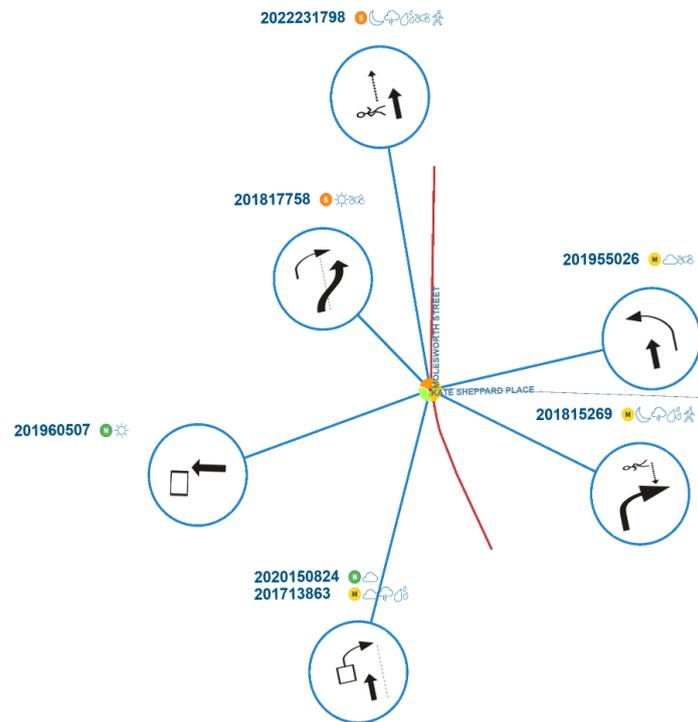
**Figure 6-2: Kate Sheppard Place and Molesworth Street intersection crash diagram**

- crashes were most often to do with manoeuvring
- two involved pedestrians (one minor and one serious)
- three occurred in wet conditions
- two occurred at night
- crashes occurred most on Tuesday or Wednesday
- crashes were well spread between 2017-2022 (with two in 2018)

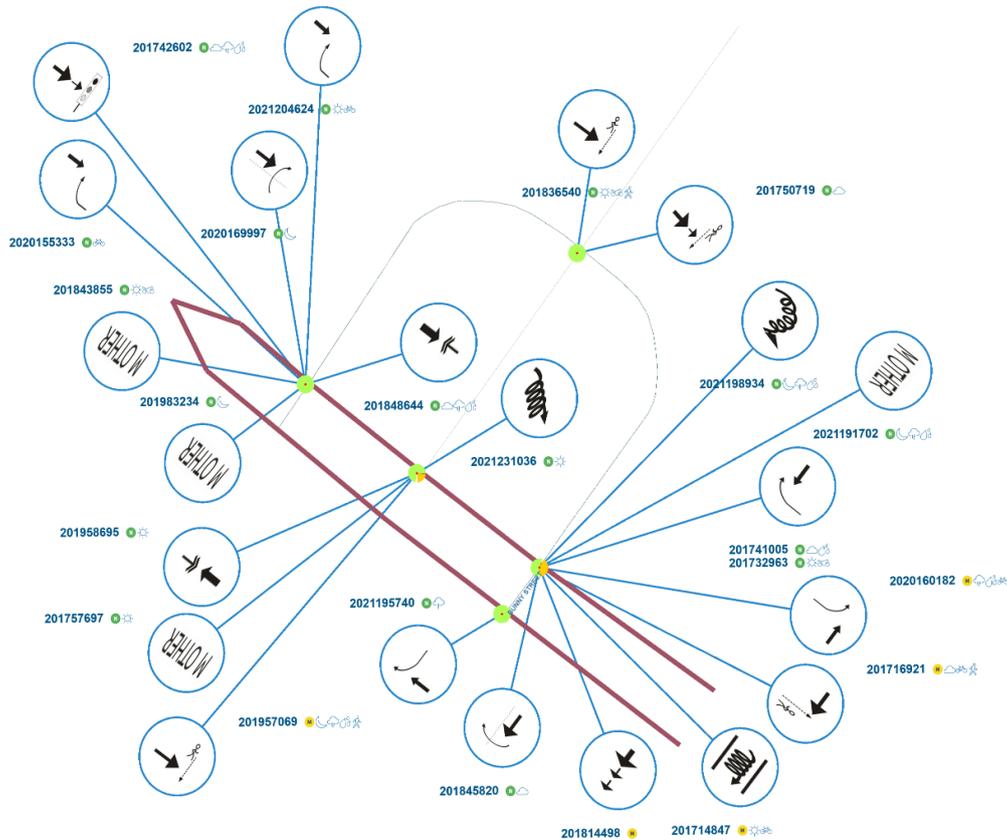
**Figure 6-3: Railway entrance and exit crash diagrams (on Bunny Street)**

- crashes were most often to do with manoeuvring
- five crashes involved cyclists (three minor and two non-injury), three involved pedestrians (two minor and one non-injury)
- most occurred in good weather
- Most crashes occurred during the day
- four of the six crashes occurred on Tuesday, Saturday and Sunday
- five of the six crashes occurred in 2017 followed by 2018 and 2021
