# Thorndon Connections cycleway audit – safety and accessibility

30% design audit

November 2022

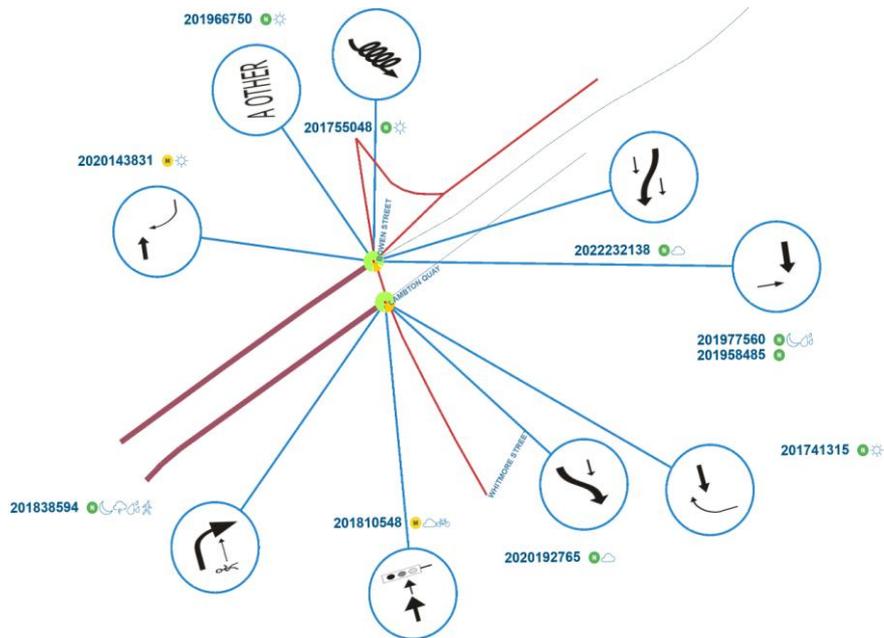
**Figure 6-4: Bowen and Whitmore Street intersection crash diagrams**

The largest crash clusters involving motor vehicles are on Bunny Street near the railway station. Other notable crash clusters are present at intersections between Molesworth Street and Kate Sheppard Place, Bowen Street and Tinakori Road, Bowen and Whitmore Street (more information on these clusters are included in Appendix A). These should be considered during the design process.

Crash data for the Bowen / Whitmore intersection shows:
